[Docket No. FAA-2017-0288; Product Identifier 2017-CE-007-AD; Amendment 39-19231; AD 2018-06-11]

Airworthiness Directives; Textron Aviation Inc. Airplanes

ACTION: Final rule.

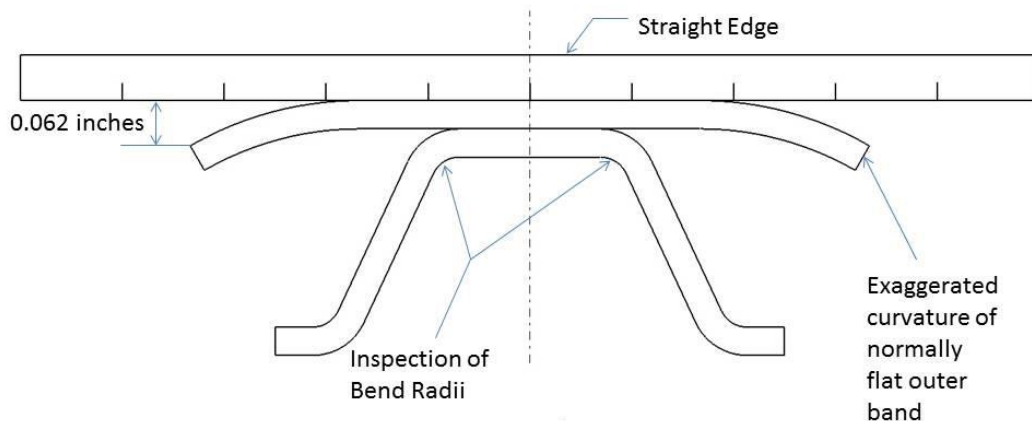
Figure 1 to paragraphs (k)(1)(iii) and (v) of this AD: Cross section of v-band coupling

(iii) Visually inspect the flatness of the outer band using a straight edge. Lay the straight edge across the width of the outer band. The gap must be less than 0.062 inches. See figure 1 to paragraphs (k)(1)(iii) and (v) of this AD. If the gap exceeds 0.062 inches between the outer band and the straight edge, do not re-install the v-band coupling. Before further flight, you must install a new v-band coupling and restart the hours TIS for the repetitive replacement of the v-band coupling.

(v) Visually inspect the bend radii of the coupling v-retainer coupling segments for cracks. Inspect the radii throughout the length of the segment. See figure 1 to paragraphs (k)(1)(iii) and (v) of this AD. If any cracks are found, do not re-install the

v-band coupling. Before further flight, you must install a new v-band coupling and restart the hours TIS for the repetitive replacement of the v-band coupling.
